SIO Shipyard Representative Bi-Weekly Progress Report		
Project: AGOR 28	Contract No.: N00014-12-C-0305	Shipyard: Dakota Creek Industries
Prepared by: Paul D. Bueren Scripps Institution of Oceanography (SIO) 297 Rosecrans St. San Diego, CA 98106	Date: 15 February, 2016	Program Officer: Robert (Tim) Schnoor Office of Naval Research 875 Randolph St ONR 321 Arlington, VA 22203-1995
Distribution Statement A: Approved for public release; distribution unlimited.		Report No. A002.094

Weekly Report 15 Feb 2016

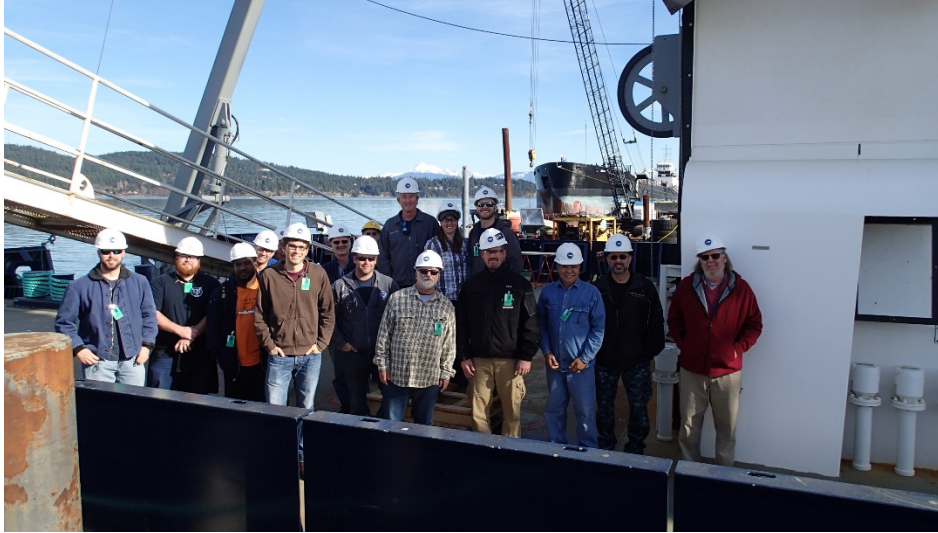
- Crew Fam has begun with 18 SIO participants.
